## 5.0 PLANNING PROCESS

The Plan Formulation section of this document follows the six step planning process defined by the USACE in the Principles and Guidelines (P&G) for water and related land resources adopted by the Water Resources Council (USACE, 2000):

Cartersville Dam is located at the town of Forsyth, Montana. The legal description of the site is: T67N R40E S14. The dam belongs to the Cartersville Irrigation District and was constructed during the early 1930's utilizing a rock- rubble riprap capped with concrete. The dam is over 800 feet in length and spans the entire channel of the Yellowstone River (Figure 5-1). The approximately 80-year old structure has experienced deterioration typical of aging dams and has required annual maintenance in recent years. The irrigation diversion dam has associated water rights dating to the late 1800's.

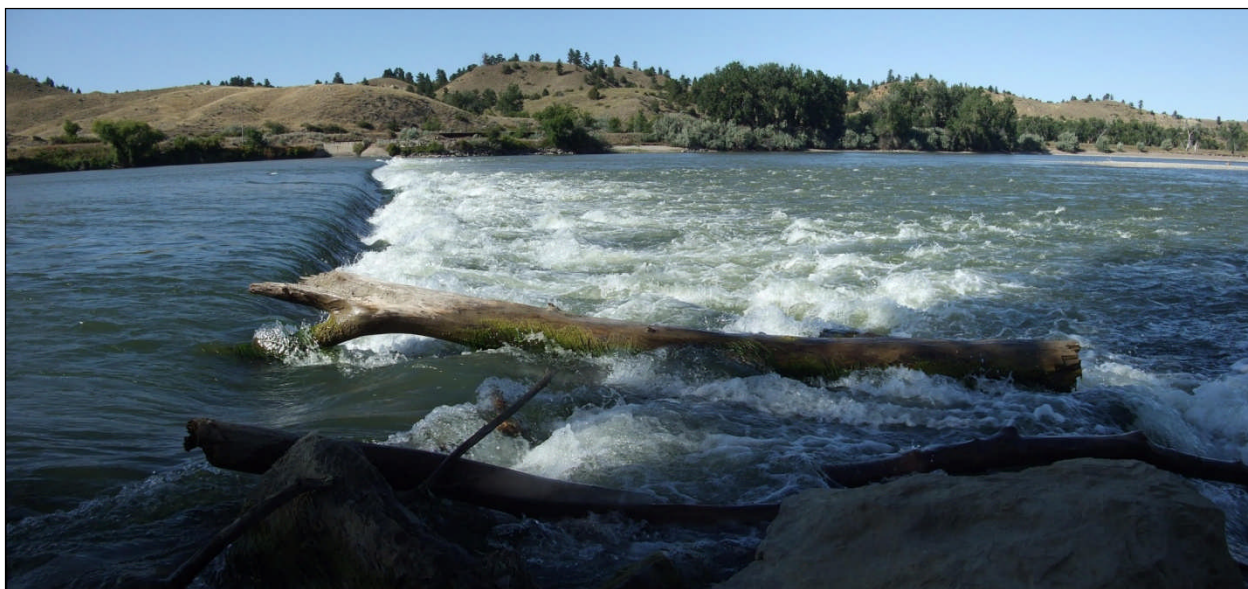
**Figure 5-1 Cartersville Dam Viewed From the Right (South) Bank During Low Discharge.**

Because this dam spans the entire river bed, it is viewed as a passage barrier to fish and boaters. The greatest passage impediment likely occurs during periods of lower flows (Bureau of Reclamation and Montana Fish Wildlife and Parks 1999). Radio telemetry data provided by Matt Jaeger of Montana Fish, Wildlife & Parks (Figure 5-2) shows examples of two shovelnose sturgeon that migrated upstream to the base of Cartersville Dam but did not pass upstream of the structure. Jaeger (unpubl. data) found that 13 out of 37 (35%) shovelnose sturgeon he monitored exhibited similar migration patterns affected by Cartersville Dam. These data clearly suggest Cartersville Dam is an upstream passage impediment to shovelnose sturgeon.

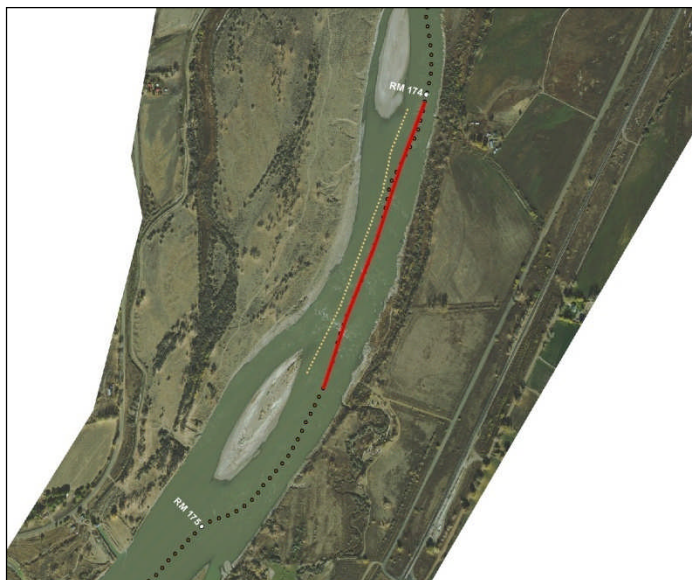
**Figure 5-15 2007 Aerial Photograph of Matthews Rapid RM 174.2, Yellowstone River; red line refers to extent of slope anomaly, and centerline points are 100 ft increments.**

Matthews Rapid, located a few miles downstream of Miles City at RM 174.2, consists of a long bedrock exposure and steep channel segment. The rapid has formed in sandstones of the Tullock Member of the Fort Union Formation (Vuke, et al, 2001). The steepest portion of the rapid extends between two mid channel bars, over a distance of approximately 0.6 miles (Figure 5-15). The LiDAR-derived water surface profile indicates that the rapid consists of a series of drops, each of which are several hundred feet long (Figure 5-16 and Figure 5-17).

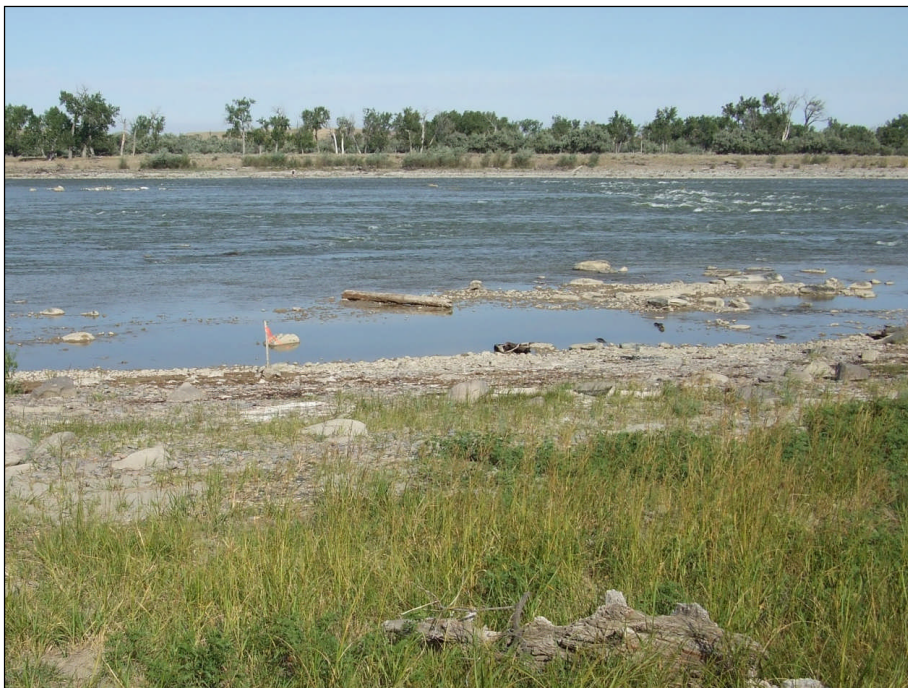
The river bed at Matthews Rapid consists of a band of large, tabular, sandstone boulders spanning the entire river channel, but no discernable bedrock sills (Figure 5-18). The large boulders are interspersed by areas with gravel and large cobbles. Deeper flow pathways are present through the rapid and may provide migration routes for fish.

**Figure 5-18 Matthews Rapid Looking North From the Right (southern) Bank**

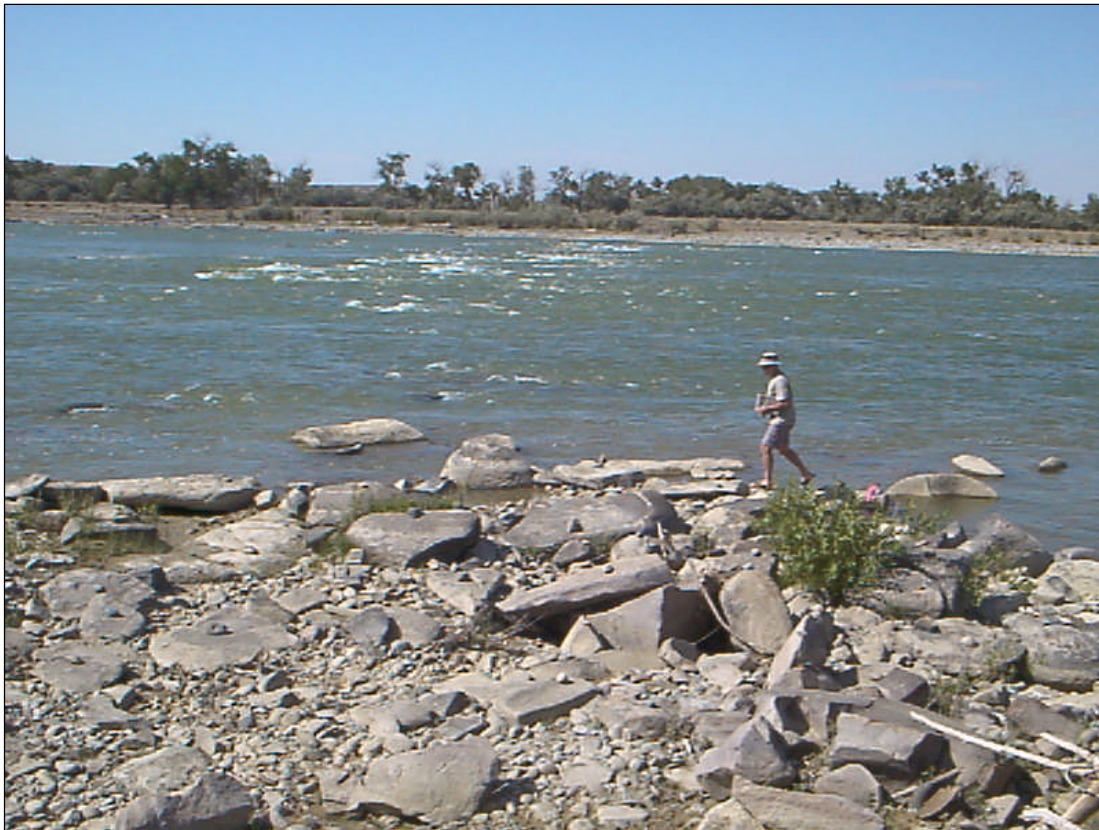
Adjacent to the steepest portion of Matthews Rapid, the right bankline is comprised of a coarse group of boulders that are continuous with the grade break in the channel (Figure 5-19). In order to estimate the size of the boulders in the rapid, a 92' X 28' cluster of boulders was flagged on the right riverbank adjacent to the steepest part of the rapid, and all boulders in the area were measured in terms of a-axis, b-axis, and c-axis lengths. A total of 144 clasts were measured and statistically summarized (Table 5-2). A box and whisker plot of the data shows that the range in 25th-75th percentile values (the "box") is relatively small, but that maximum values are notably large, reaching 148 inches (12.3 feet) for the largest boulder measured (c-axis; Figure 5-20). A histogram showing results for all measurements less than 65 inches shows that the highest number of occurrences for the a-axes is 5 to 15 inches, for b-axes is 15-20 inches, and for C axes is 30-35 inches (Figure 5-21).

**Figure 5-19 View From Right (southern) Bank Showing Steep Section of Matthews Rapid with Coarse Boulder Field in Foreground.**

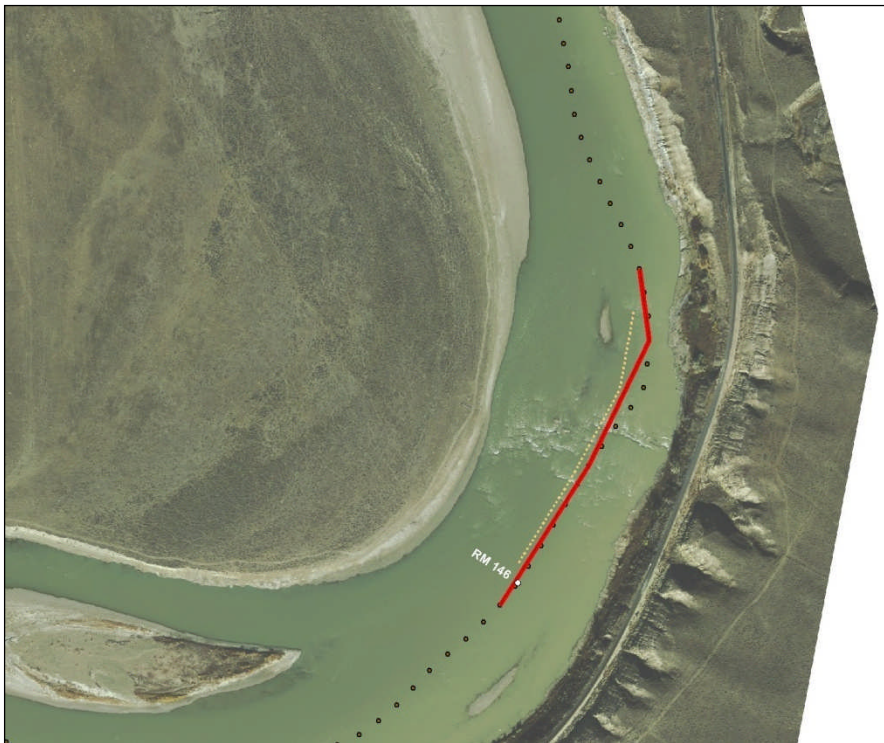
**Figure 5-22 2007 Aerial Photograph of Wolf Rapid, RM 146  
Yellowstone River; red line refers to extent of slope anomaly and centerline  
points are 100ft increments.**

Wolf Rapid is located at River Mile 146.0, approximately 3 miles downstream from the mouth of the Powder River (Figure 5-22). This rapid consists of a series of bedrock sills that extend across the channel on the apex of a large bendway. Similar to Matthews Rapid, the mapped geology on the base of the adjacent valley walls consists of interbedded sandstones, mudstones and limestone of the Tullock Member of the Fort Union Formation (Vuke and Colton, 2003). These hard sandstones appear to form the grade break at Wolf Rapid. At Wolf Rapid, the water surface slope is consistently steeper than 0.3% over several hundred feet of channel (Figure 5-23 and Figure 5-24).

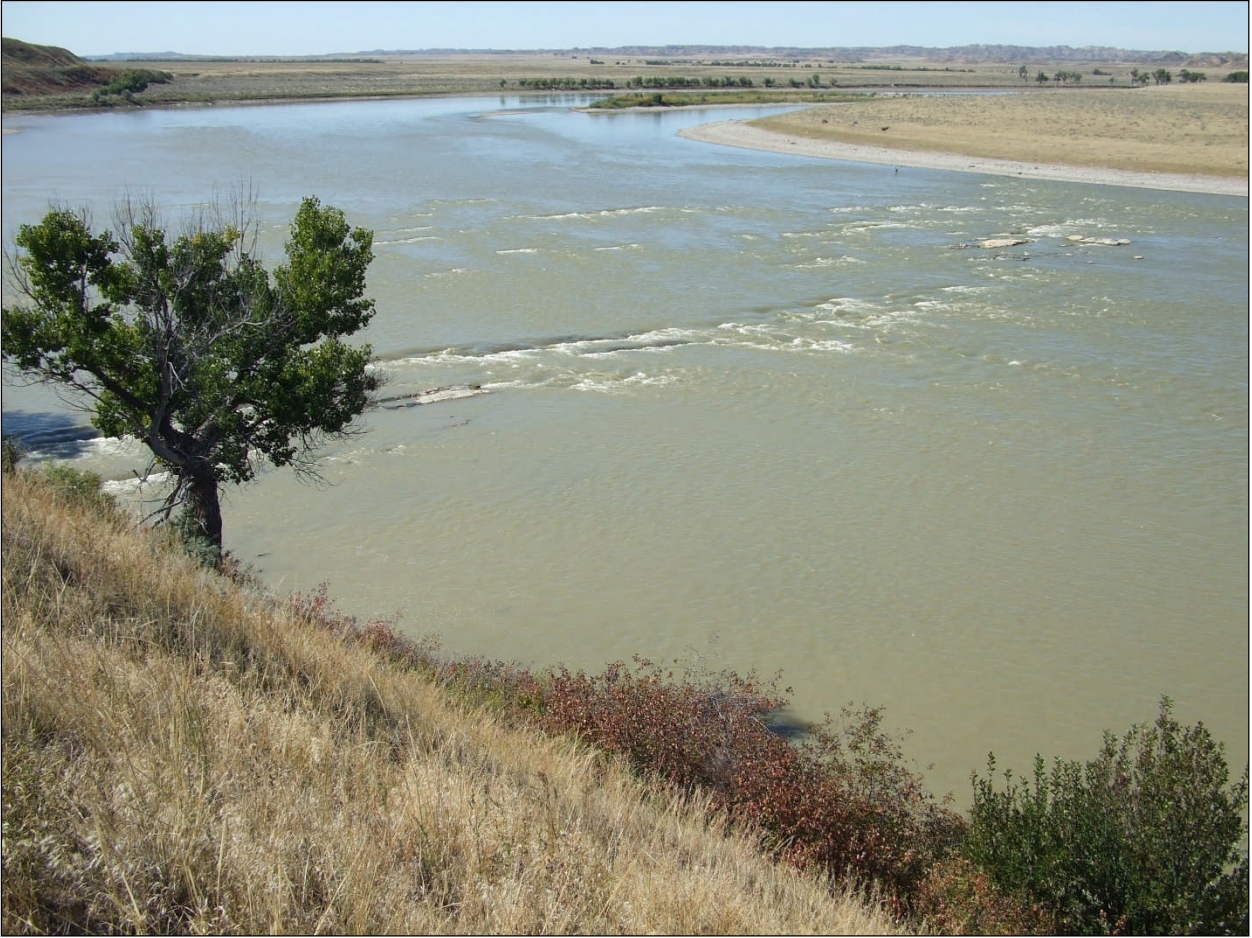
The river bed at Wolf Rapid consists of a series of discontinuous sandstone steps created by bedrock sills (Figure 5-25). The rock sills cross the channel obliquely and slope downward from south to north. Consequently, flows on the north side of the rapid are deeper than on the south side. The sills are breached, creating chutes with well-defined, deeper flow pathways around and through the bedrock sills that might be used by sturgeon for passage. Flows over the tops of the rock sills exhibit supercritical flow conditions. The rock sills are interspersed by sections of river bed with more consistent grade and large cobble to large boulder substrates.

**Figure 5-25 Wolf Rapid Looking Northwest From the Right (southeast) River Bank**

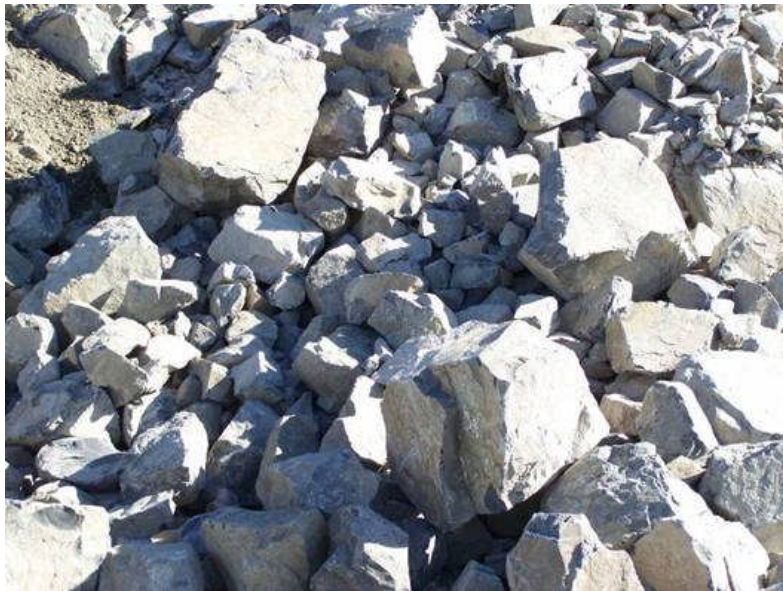
The rock from Pipeston Quarry near Whitehall is upper Cretaceous age, porphyritic intrusive basalt/diorite (Figures 5-52 and 5-53). The rock is very dense, silicified and fractured, with no known occurrences of base or precious metal mineralization within the proposed quarry area. Refraction seismic data obtained on January 7, 1991 shows an average velocity of bedrock to be 5740 ft/sec. to a minimum depth of 50 feet (the bulk specific gravity of the bedrock is 2.852 and density of 2.4 tons per bank cubic yard). The rock would be loaded on Montana Rail Link (MRL) trains and delivered to Forsyth. Rock would then be transferred to trucks, delivered to the diversion dam, and placed in the river. A constraint is that MRL only has seven side-dump railcars which are used extensively for repairs to MRL facilities. Rock is priced at \$9/ton for these quantities. Rail delivery to Forsyth is \$2900/car (approximately 100 tons) or \$2500/car if MRL doesn't supply the cars.

**Figure 5-52 Riprap**

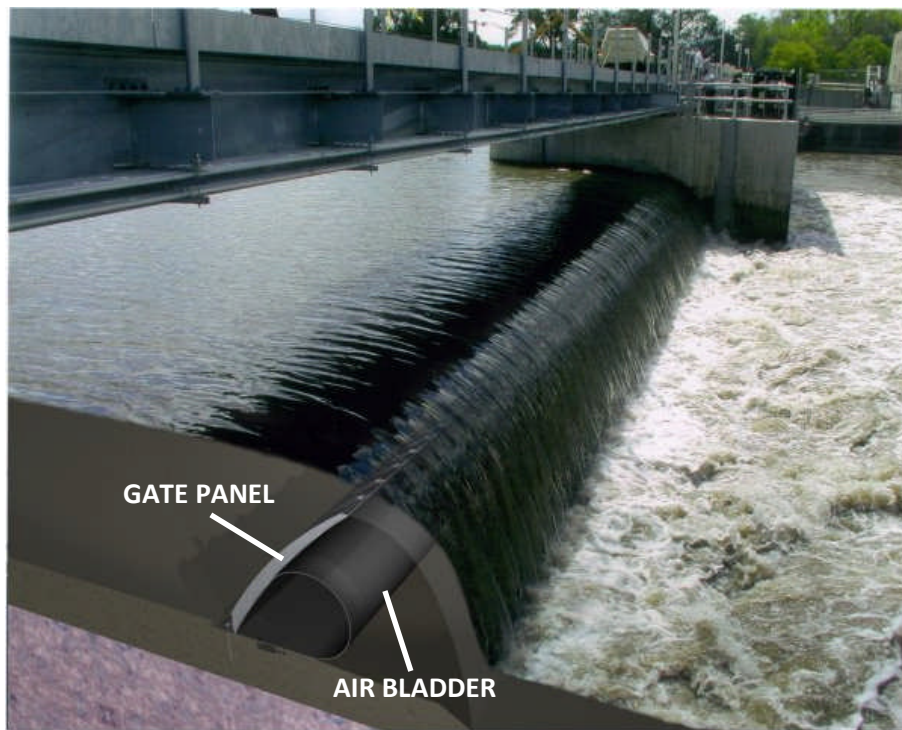
The bladder would be as manufactured by Obermeyer Hydro, Inc. The inflatable bladder would sit on a concrete pad with a steel plate on the upstream face to protect the bladder from damage due to ice and debris. These gates have been used extensively in areas with significant ice, such as Finland. The reinforced bladder is inflated at low pressure. The height of the bladder with steel plate would be approximately 6 feet, the estimated height of the existing dam (Figure 5-55). The bladder can be constructed in as many sections of specified width as desired. Each section can be operated independently to any desired height. This allows operation that best meets the needs of the irrigators and fish passage.

**Figure 5-55 Obermeyer Gate**

Some have voiced concern that an inflatable bladder would be vulnerable to puncture by gunshot. However, if a gunshot were to puncture the bladder the hole should self seal or the air loss could easily be made up with a small air compressor.

With all segments of the inflatable bladder in the raised position, the dam hydraulics would approximate the existing condition. With all the segments in the lowered position the river would essentially return to a semi-natural condition, allowing unimpeded passage of fish and bedload.
